Full-Scale Transport Controlled Impact Demonstration

Proceedings of a workshop held at
NASA Langley Research Center
Hampton, Virginia
April 22, 1986

Robert J. Hayduk, *Compiler*
Langley Research Center

Proceedings of a workshop sponsored by
NASA Langley Research Center, Hampton,
Virginia, and the FAA Technical Center,
Atlantic City, New Jersey, and held in
Hampton, Virginia
April 10, 1985

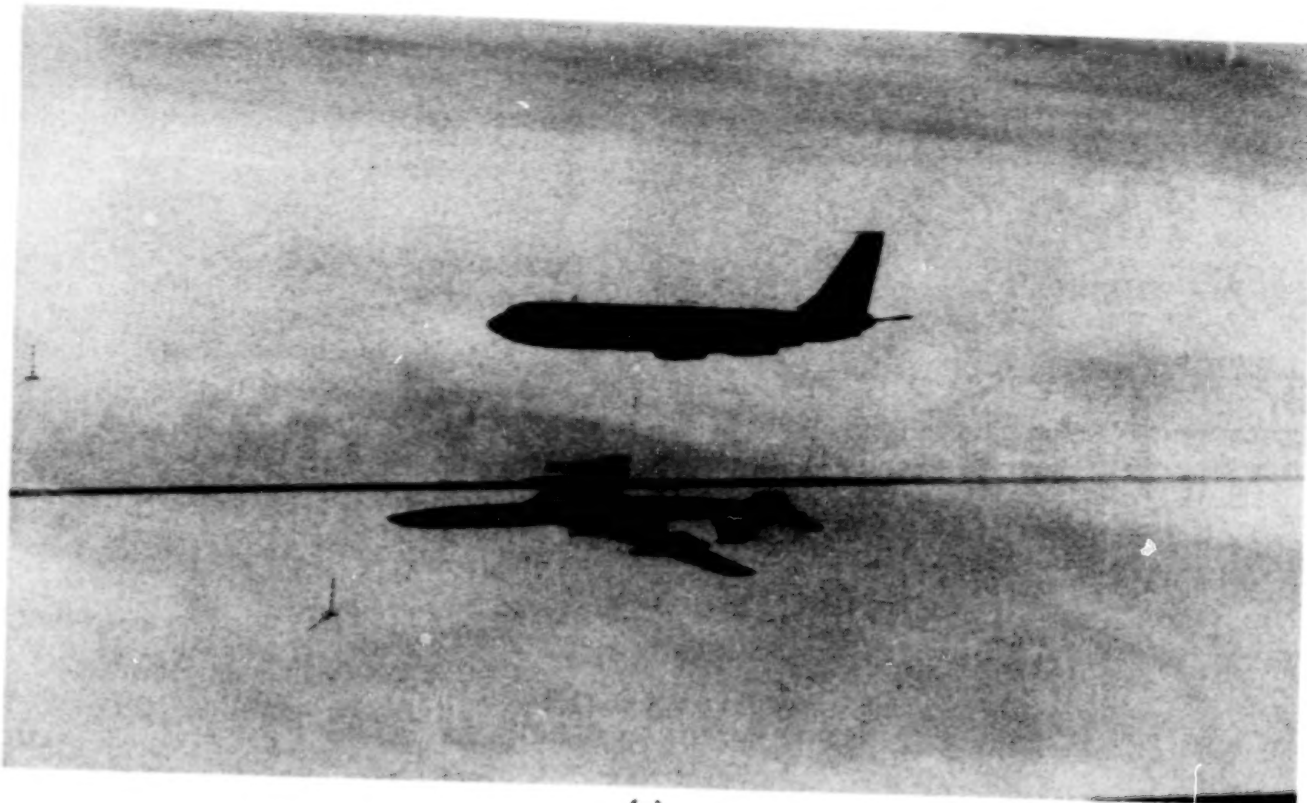
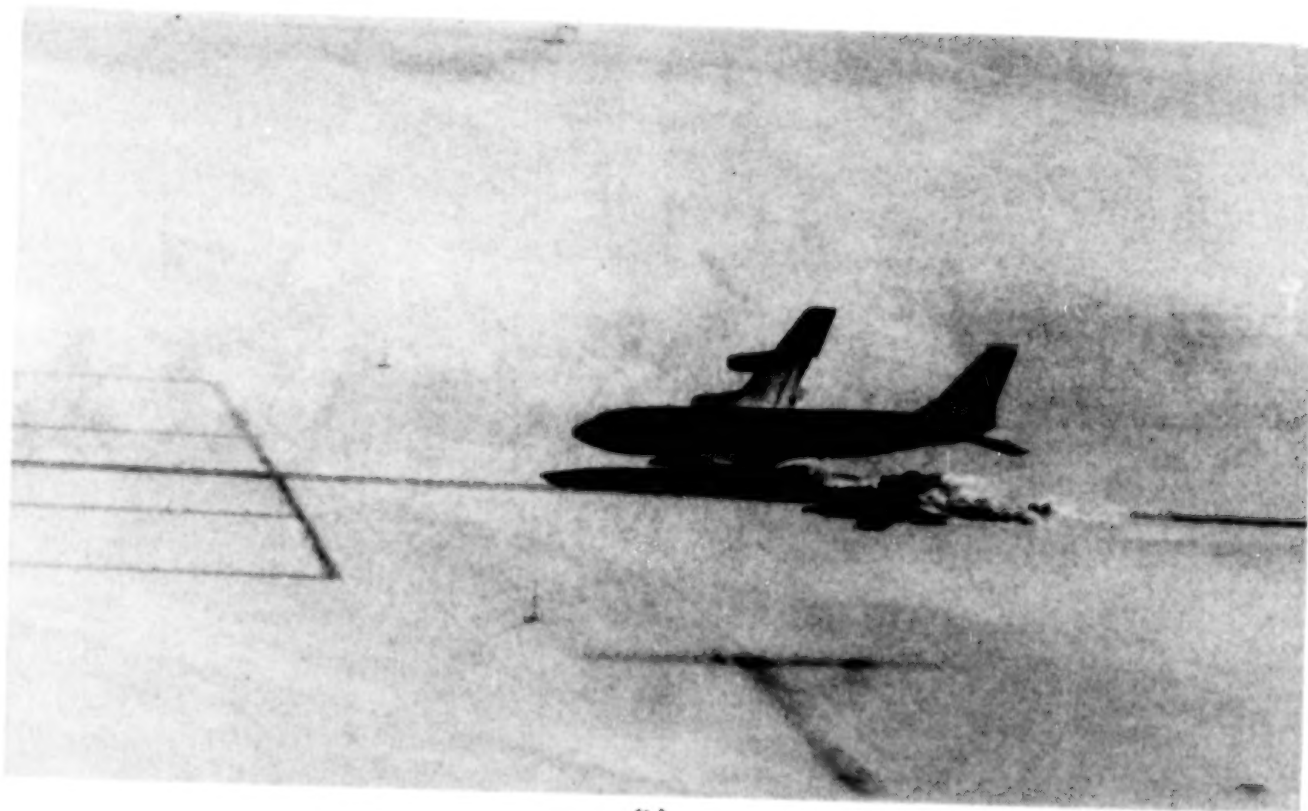
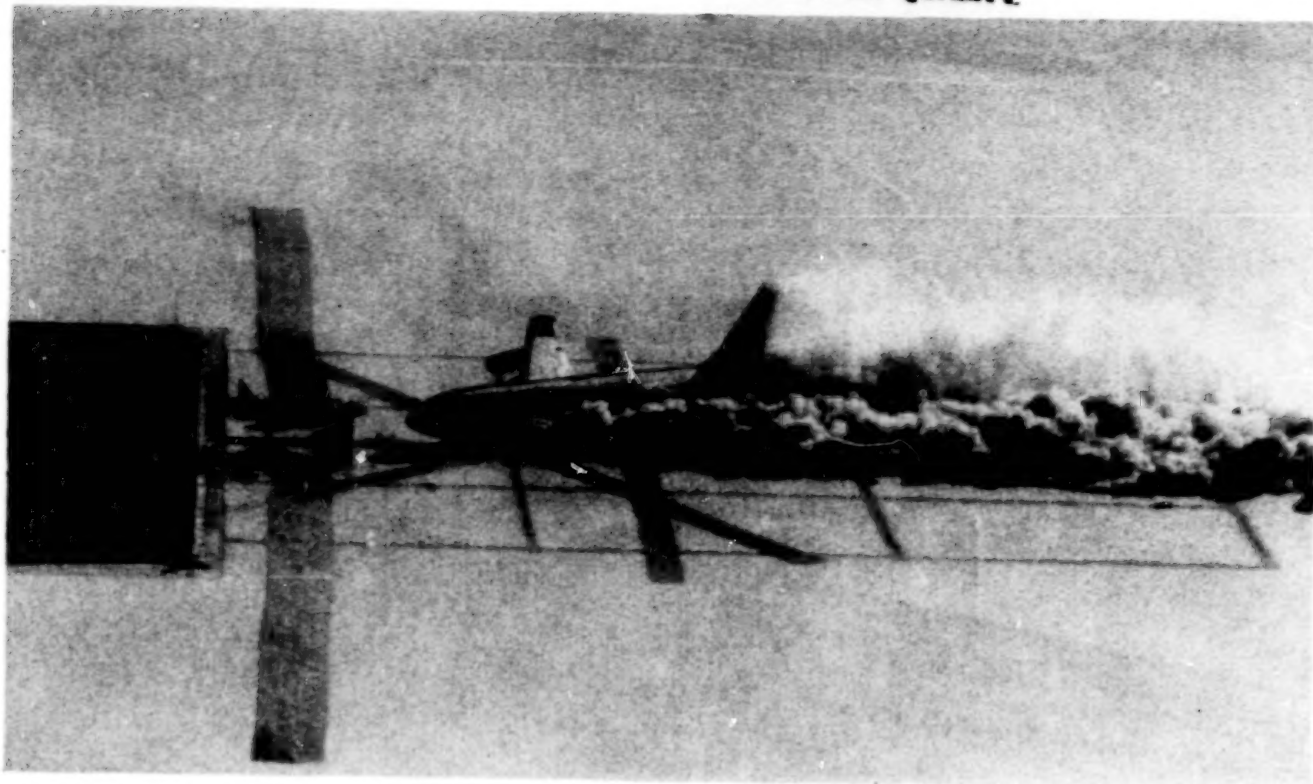
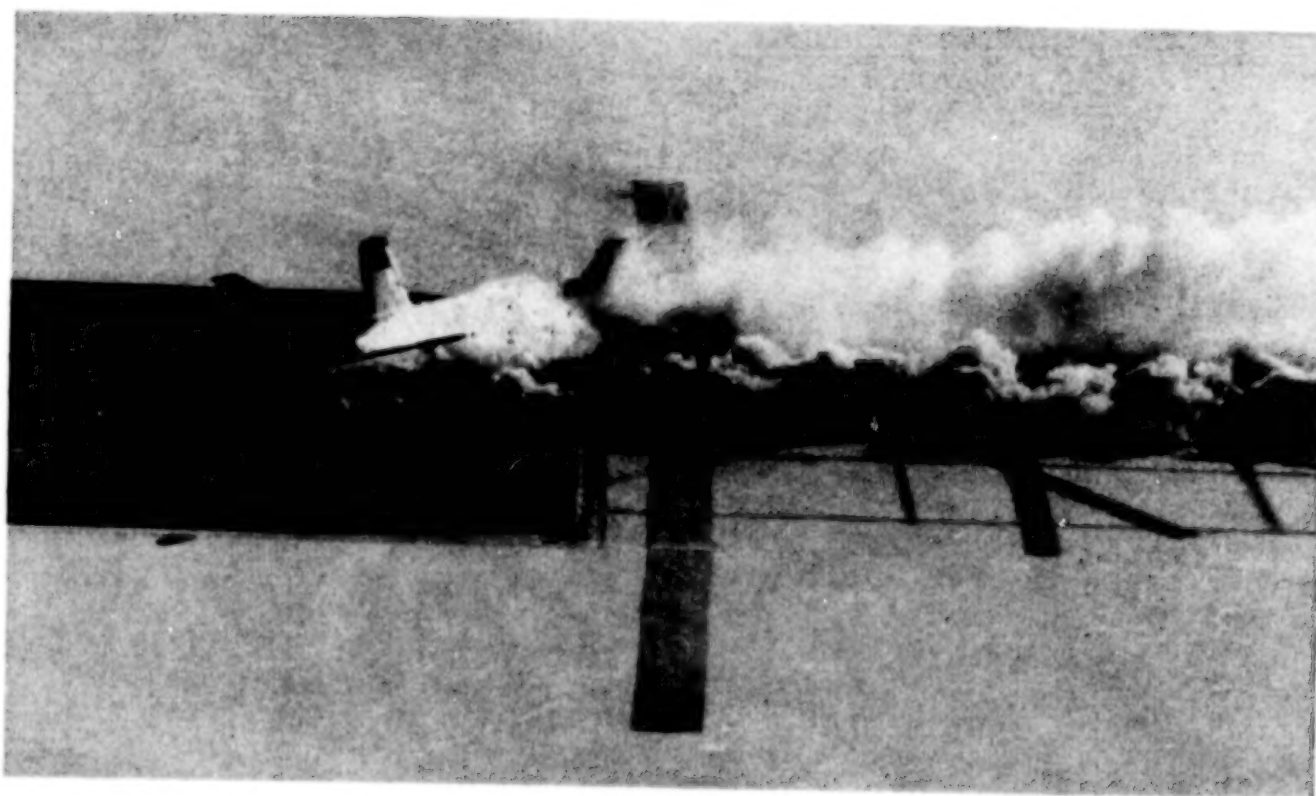
Figure 13. CID impact.

Figures 13a, 13b, 13c, and 13d are a sequence of photographs that show the airplane just prior to impact. They show the no. 1 engine impacting first and then the fuselage. It is interesting to note that the engines on the left wing are really distorted.

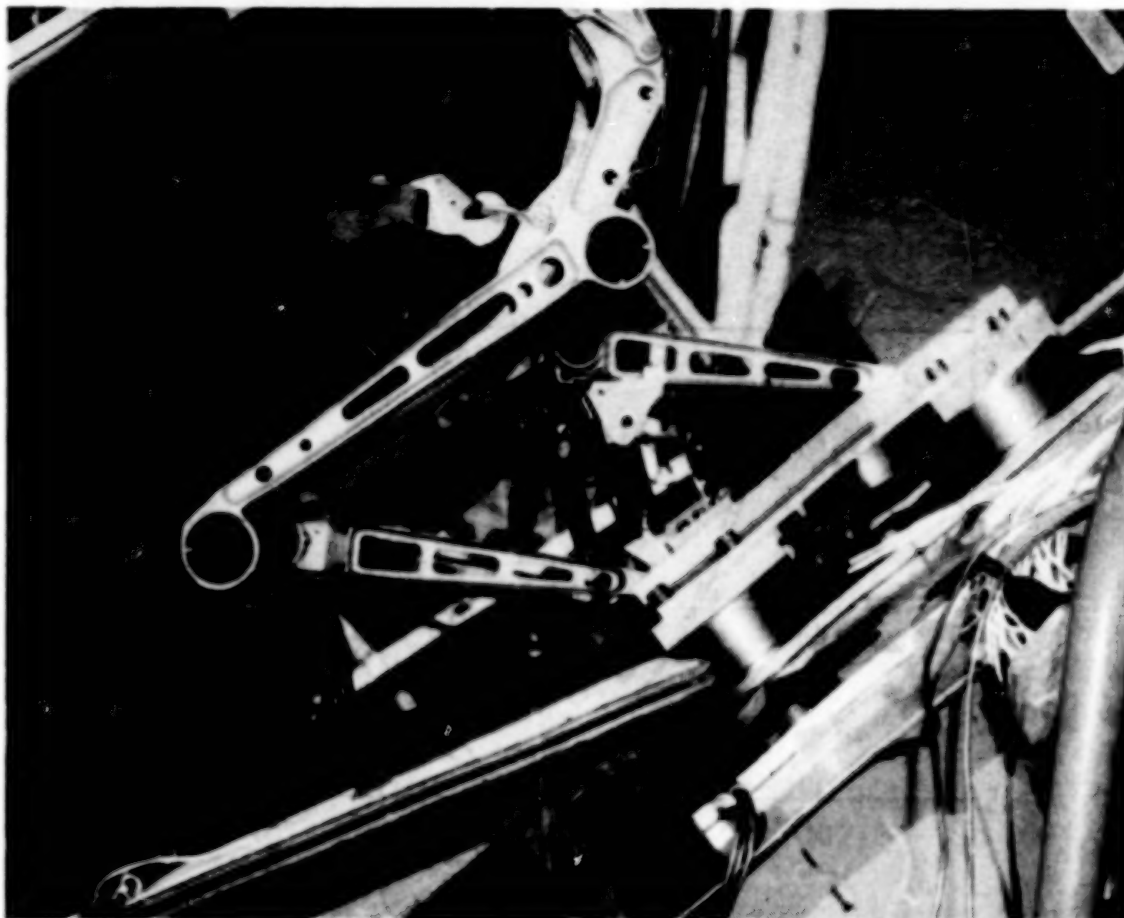
DYNAMIC IMPACT TEST - STROKED SEAT

The energy absorbing seat is shown in the stroked position after the drop test. The seat started to stroke at approximately 11 g's and the stroke length was about 5 inches. The seat and energy absorbing mechanism worked satisfactorily.

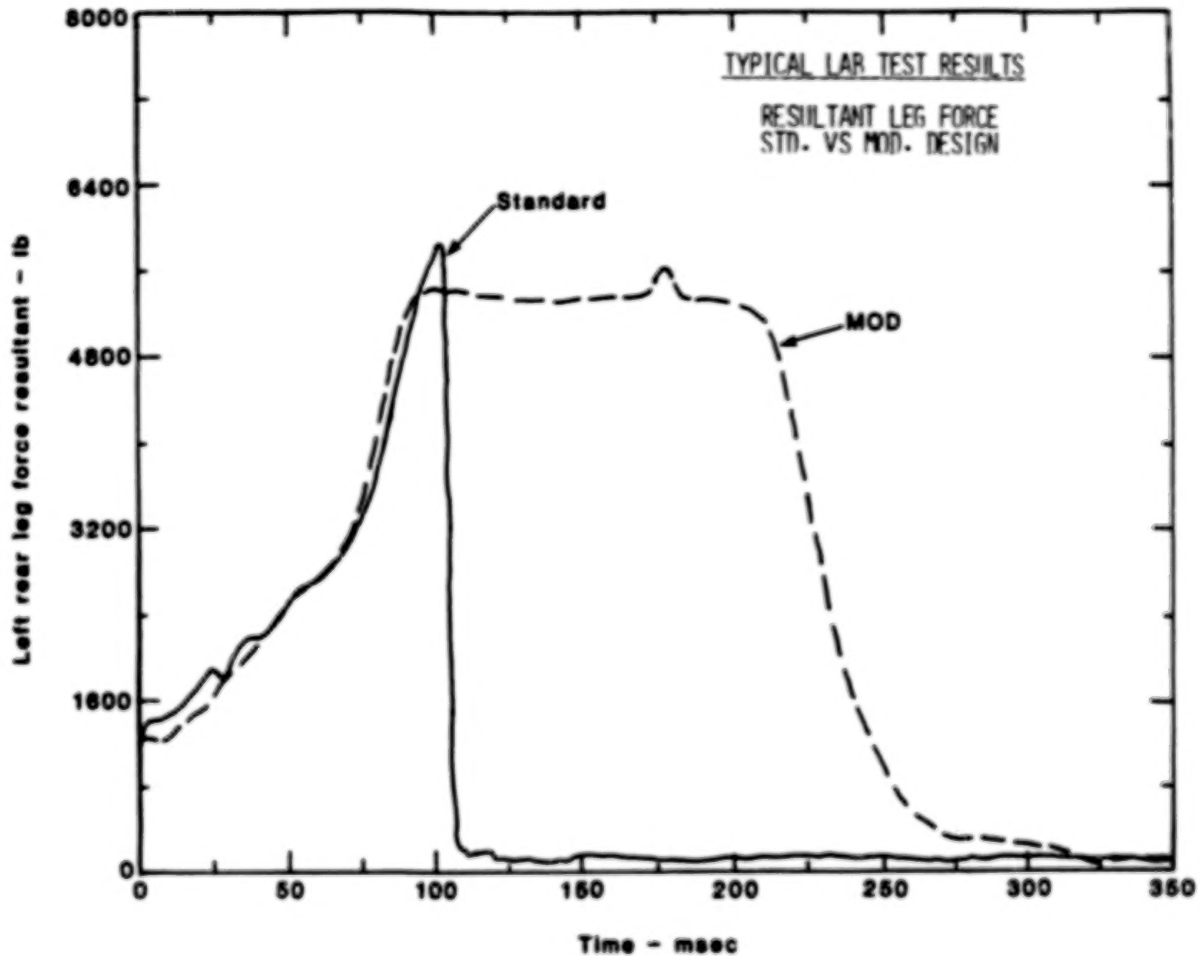
TYPICAL LAB TEST RESULTS

This typifies the dynamic test results between one of the CID standards and a modified seat design. Shown are the window-side leg forces versus pulse duration. At a 9G 50-ft/sec dynamic pulse, the leg of the standard seat detached from the track fitting at 5900 lbs. The energy absorbing leg of the modified design stroked 3 inches and limited the load on the fitting to 5370 lb for 110 seconds. No failure was observed on the modified seate(weight increase due to the energy absorbers was 2 percent).

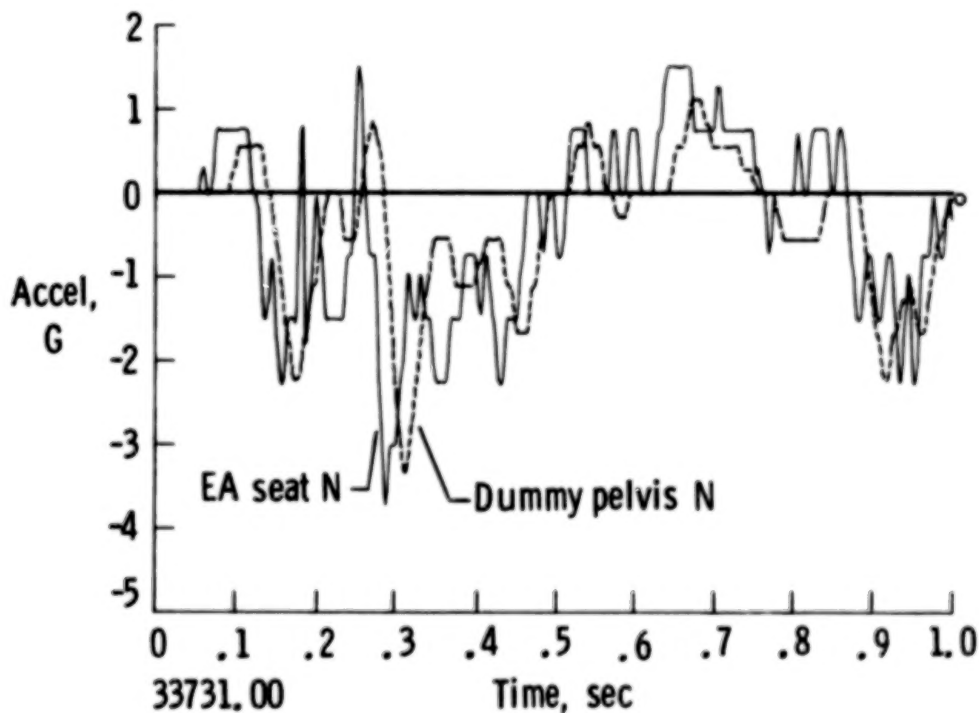
Figure 4

In figure 4 the dummy (14B) pelvis normal acceleration (along the spine) for the primary ground impact (wing cutter data not considered) is compared to the EA-seat normal (to floor) acceleration. Notice that the dummy pelvis acceleration follows the EA-seat acceleration rather closely except that it lags slightly in time. Also note that the peak acceleration is less than four G's, with the average acceleration down in the 1 to 2 G range and with durations approaching 0.2 seconds. Referring to figure 2, one can see that these levels are quite low and in the non-injurious range. This seat was designed to begin stroking for a normal input acceleration of approximately 8-10 G's. Since the input acceleration is well below that value, the graphite/epoxy energy-absorber would act as a solid member with no stroking.

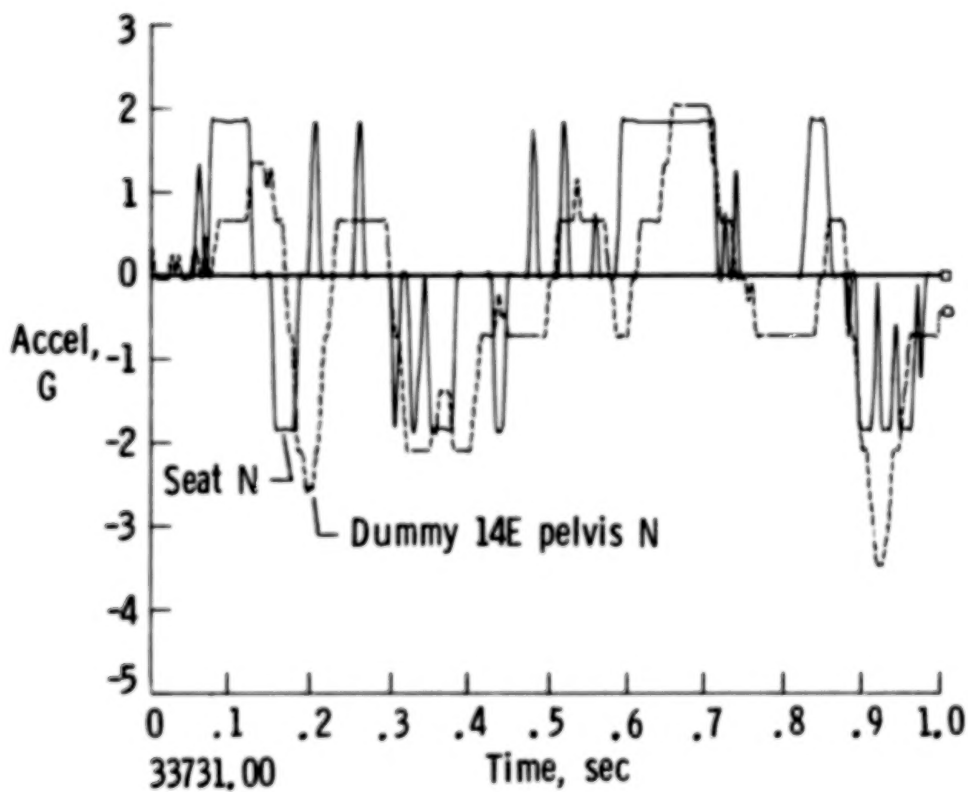
Figure 5 uses the same format as figure 4 except that the NASA standard seat and dummy 14E pelvis accelerations are compared. Notice that the normal dummy pelvis acceleration in the standard seat also follows the seat normal acceleration quite closely except for some time lag. Since the input pulse was below the stroking level for the EA-seat, both seats and both instrumented dummies experienced comparable acceleration pulses.

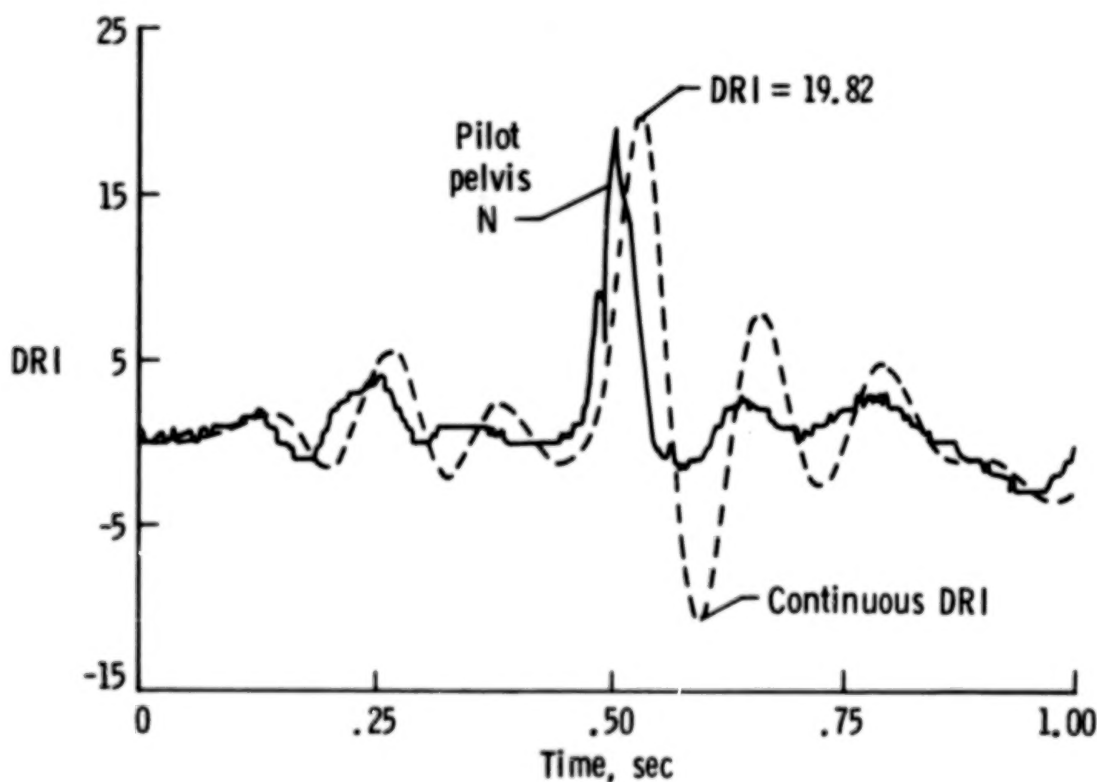
The dummy pilot received the highest normal (spineward) acceleration because the pitch rate imparted by the wing impact caused the aircraft nose to hit first with the highest vertical velocity. Figure 6 shows that the pilot normal pelvis acceleration peaked at 18.3 G's with base duration of about 0.07 seconds. The average acceleration over the 0.07 seconds is about 10 G's. In addition, the continuous DRI was plotted using the pelvis acceleration as the forcing acceleration. The peak DRI lags the input and slightly exceeds it at 19.8. By comparing the peak and average acceleration for 0.07 seconds with the curve in figure 2, one can see that the acceleration borders the moderate injury range. Referring to figure 3, a DRI value of 19.8, would indicate a 10-percent chance of spinal injury.

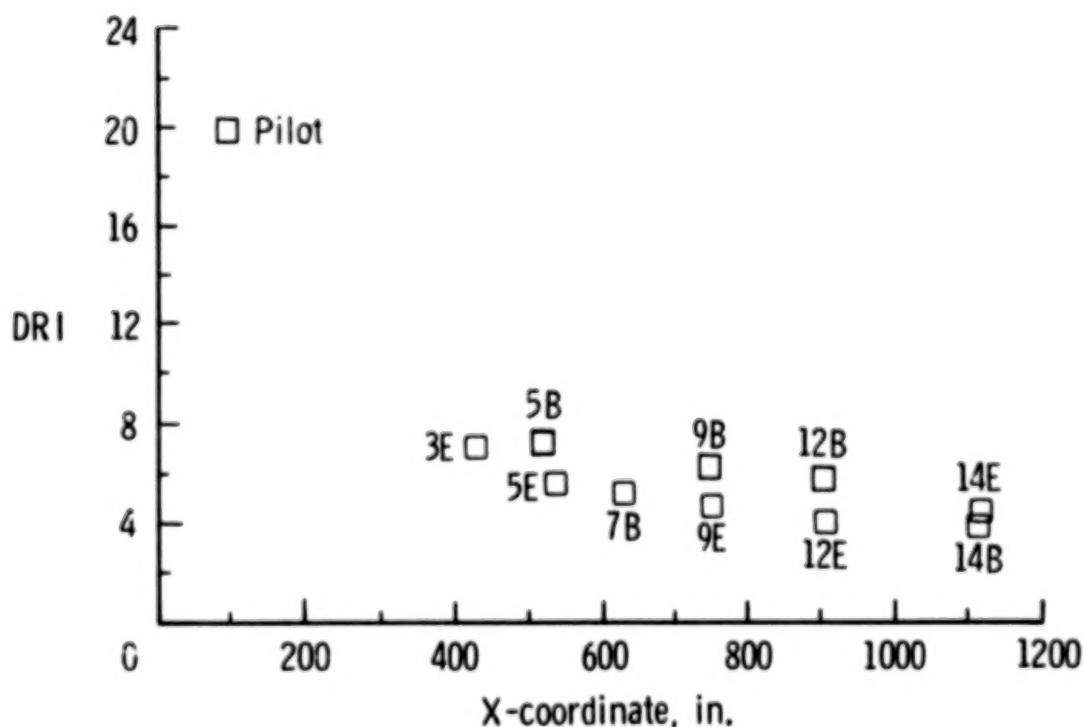
Figure 8

The dummy DRI was calculated for each instrumented dummy with good data traces and plotted versus the aircraft x-coordinate. The pilot was the only occupant that received a moderate acceleration. All of the other dummies received mild non-injurious accelerations. The number in front of each data point is the row number. The letter refers to the location from left to right with A being the far left seating position and F being the far right seating position. All instrumented dummies were located in the center position of each triple seat, thus they are in locations B and E (fig. 8).

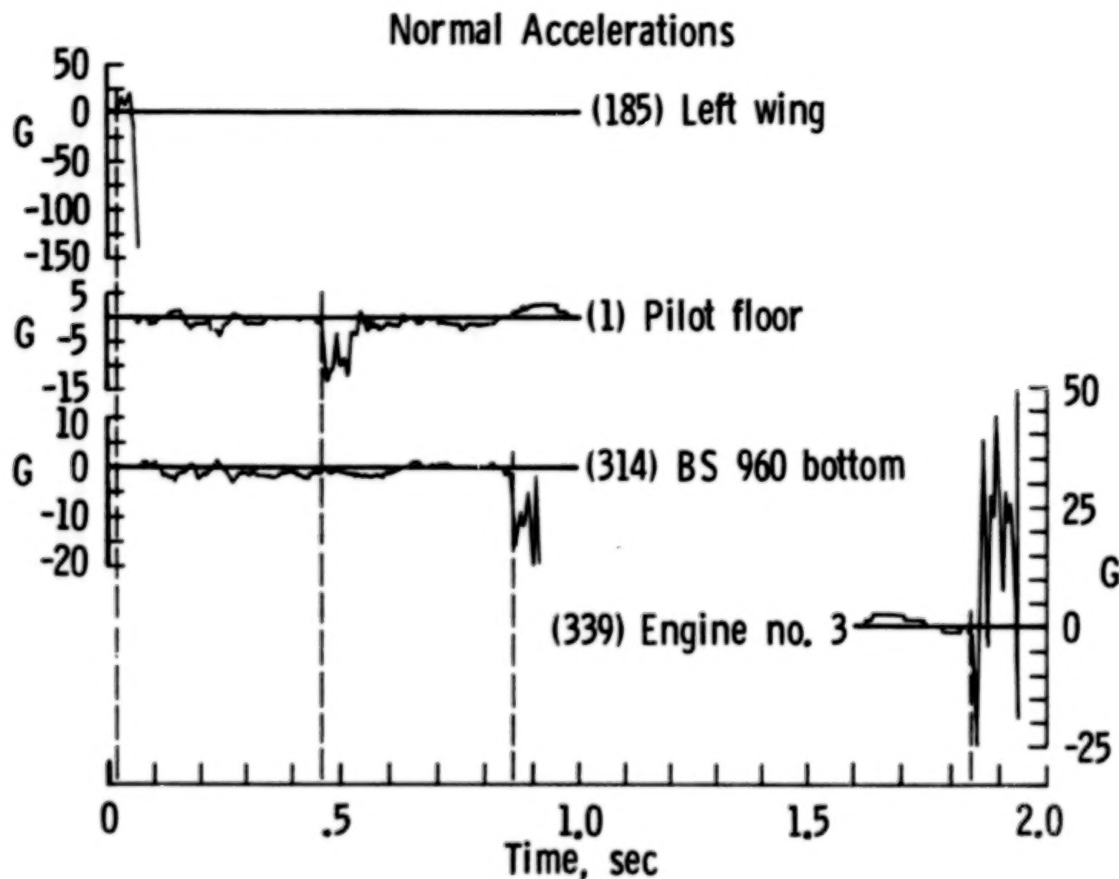
C.I.D. SEQUENCE OF EVENTS

The sequence of events during the impact of the airplane to the ground started with the left wing touching the ground at 9 hr 22 min 11.02 sec in a -12 degree roll. As the airplane continued its descent it pitched down about 3 degrees and the forward cabin at Body Station 380 hit the ground at 11.46 sec. The airplane continued to slide and to rotate downward and the bottom of the fuselage at Body Station 960 hit the ground at 11.86 sec. Sliding continued and the airplane yawed to the left until engine #3 hit the wing cutters at 12.843 sec. The airplane stopped moving at 9 hr 22 min 21 sec.

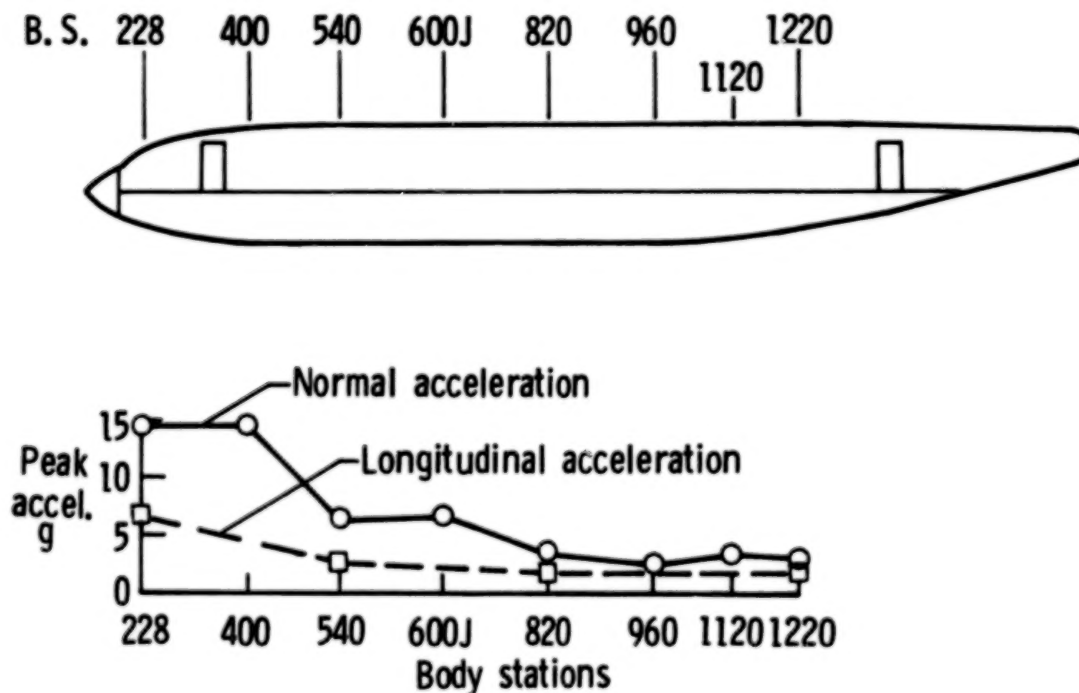
FLOOR ACCELERATION PEAKS DISTRIBUTION

The distribution of acceleration peaks in the normal direction from front to rear of the fuselage shows higher accelerations at the front of the airplane diminishing toward the rear. Under the pilot seat and at Body Station 400 acceleration peaks of 14 g were recorded. Body Station 380 was the area of the fuselage's initial contact with the ground due to the 3 degree pitch down of the airplane. The normal accelerations decrease to 6 and 7 g's in Body Stations 540 and 600J respectively and continue to decrease to less than 5 g toward the rear of the airplane.

The longitudinal accelerations follow a similar pattern: higher at the front of the airplane (6 g) where the fuselage initial impact with the ground occurred and diminishing toward the rear (2 g).

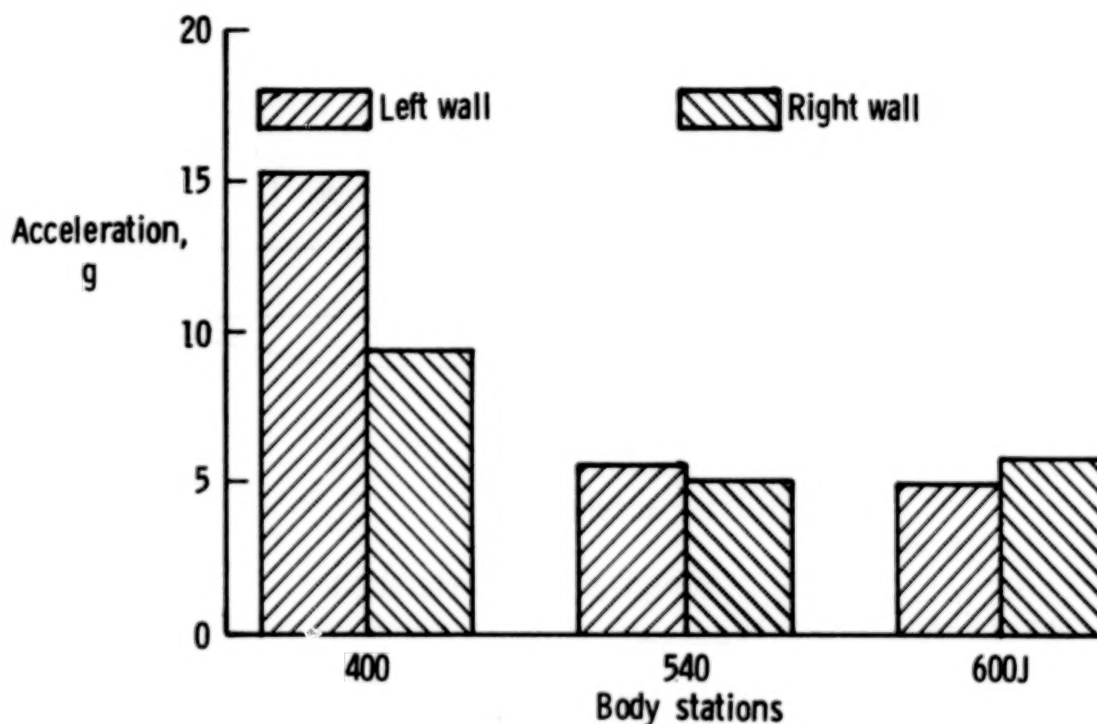
C.I.D. VERTICAL FLOOR ACCELERATION

The left side of the airplane forward of Body Station 540 experienced higher accelerations than the right side. At Body Station 540 and rearward the difference in acceleration between left and right sides is about +1 g. The magnitude of the accelerations seemed to vary with the contact position of the fuselage with the ground. The airplane had a negative roll (left) and the fuselage impacted pitched down. At this time the acceleration on the left side at the point of impact is higher. As the fuselage continues to pivot down and rotate to the right the difference in acceleration between right and left sides becomes smaller.

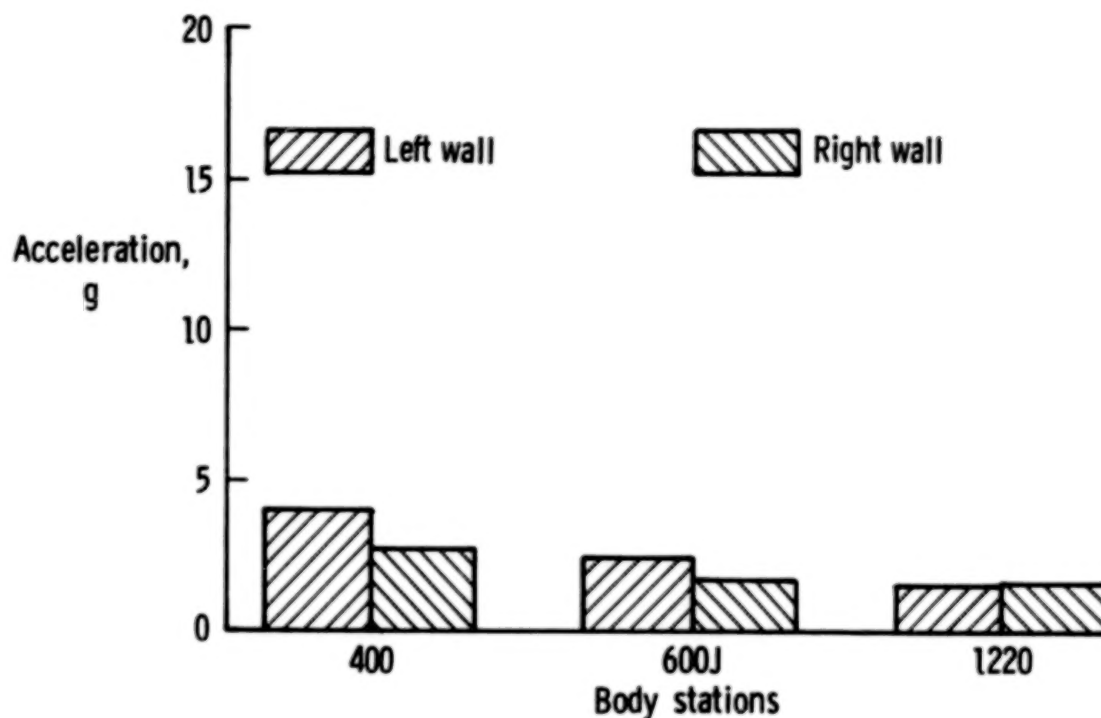
C.I.D. LONGITUDINAL FLOOR ACCELERATION

Similar to the pattern of the vertical accelerations, the longitudinal accelerations are also higher on the left side toward the front of the fuselage with the difference between left and right values diminishing toward the rear.

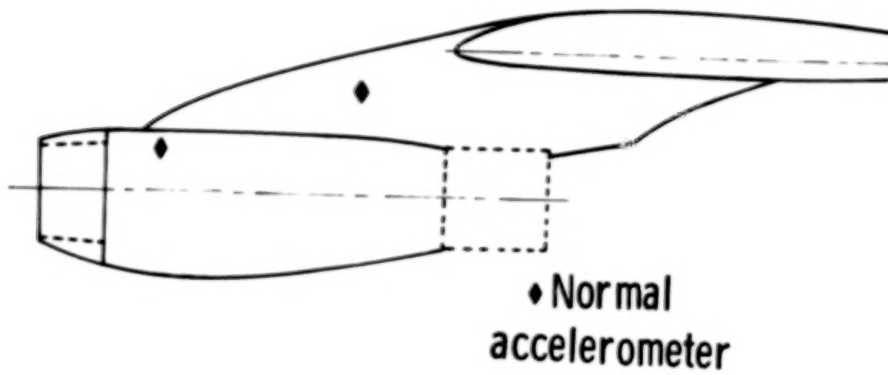
INBOARD NACELLE AND STRUT

On the left wing an acceleration peak of 36 g was obtained toward the front of the inboard pylon and 150 g in the rear of the pylon. On the right wing an acceleration peak of 5 g was obtained toward the front of the inboard pylon and 29 g in the rear of the pylon.

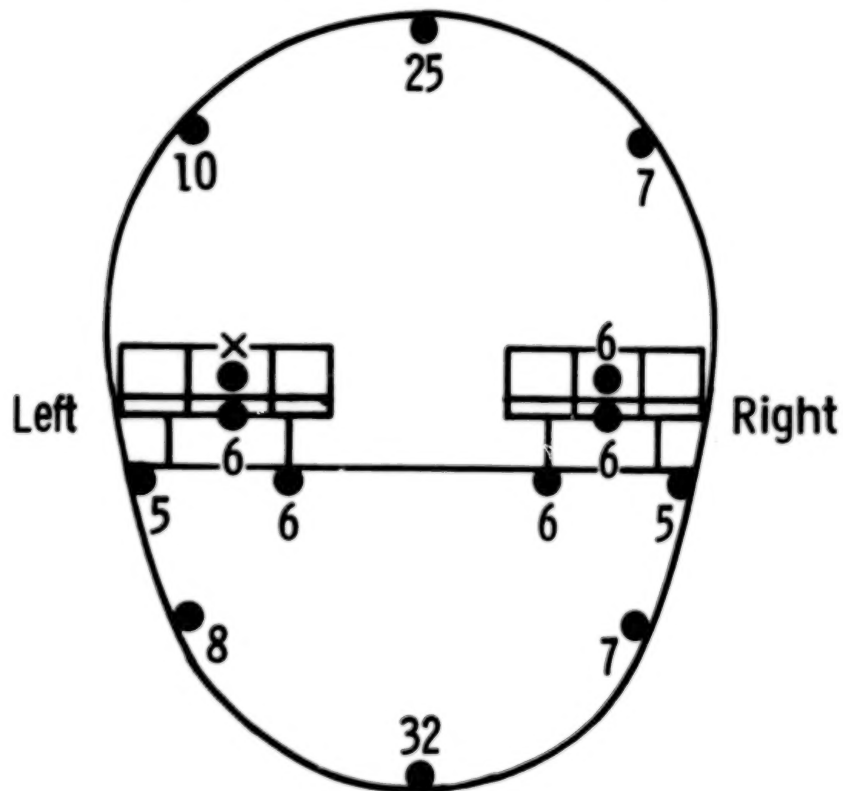
Normal Acceleration Peaks

This is a cross section of the instrumented frame at Body Station 540. The values shown are normal acceleration peaks recorded at those locations to determine the transmission of pulses from the ground up. Peak accelerations obtained were 32 g at the bottom, 7 - 10 g at the subfloor and upper wall, 6 g at the floor, and 25 g at the roof of the fuselage. On the seat frame and dummy pelvis, an acceleration of 6 g was obtained.

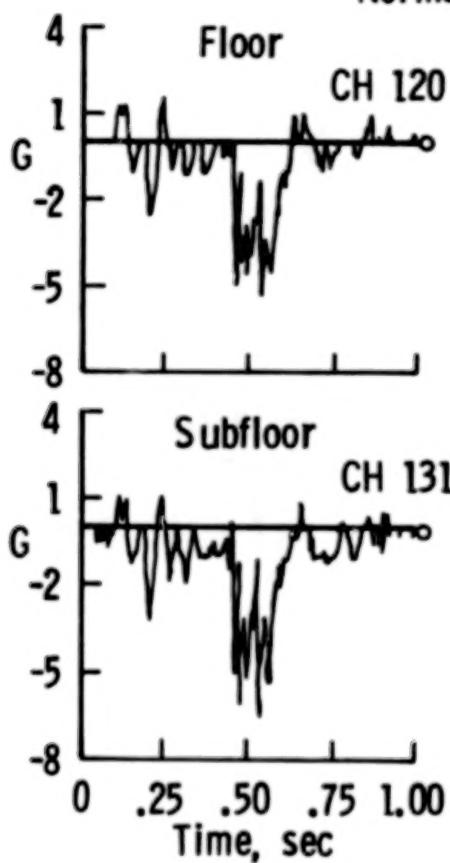
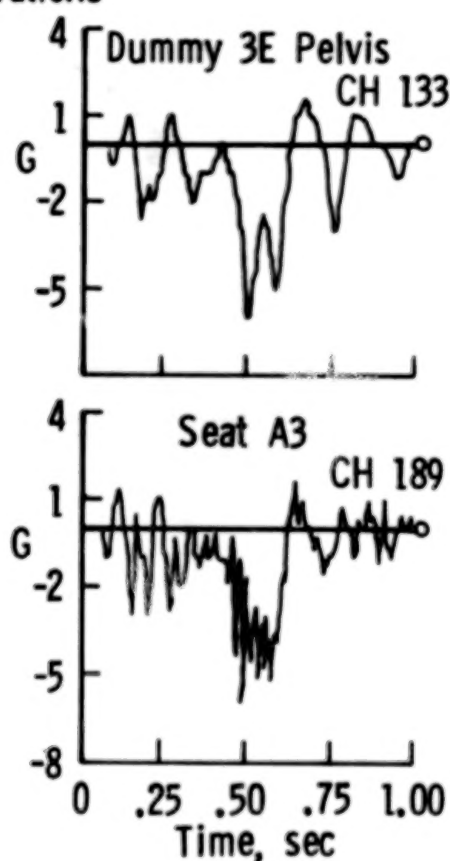
Normal Accelerations

These acceleration time histories were measured on the right side of frame #2 at Body Station 540. The subfloor trace shows acceleration peaks of 7 g. At the floor-wall intersection the acceleration is 5 g. The acceleration on the seat frame is 6 g and at the dummy pelvis the acceleration is 6 g.

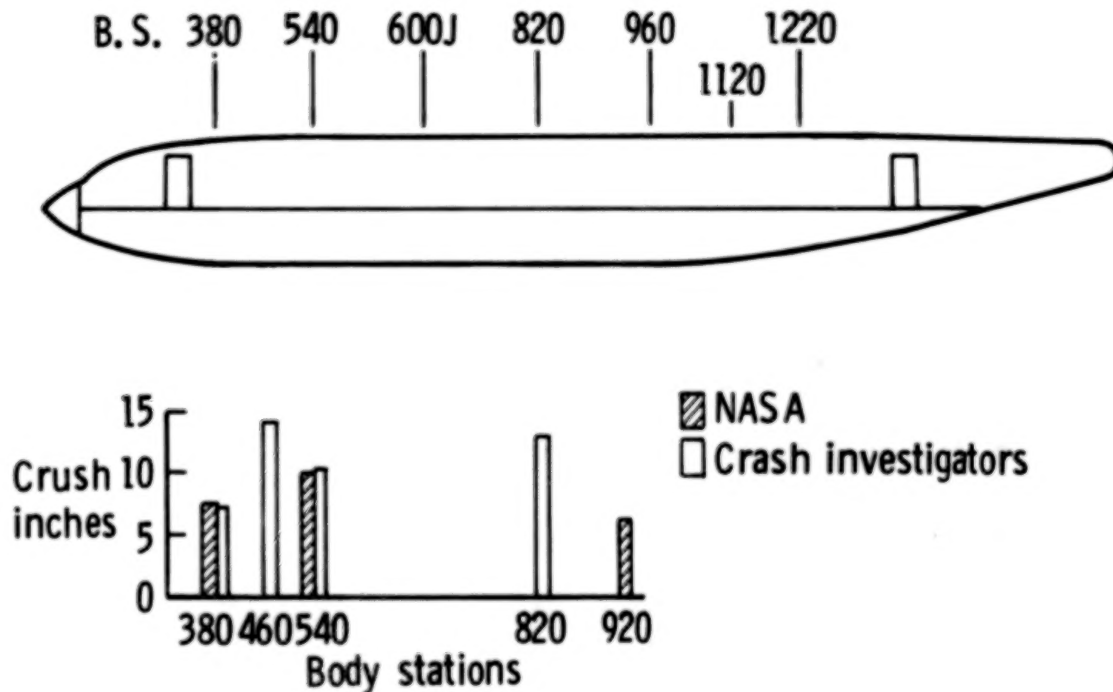
FUSELAGE CRUSH (PRELIMINARY)

A NASA team and a crash investigators team measured the crush of the fuselage bottom. The crush measured by the NASA team was 7" at Body Station 380, 10" at Body Station 540, and 7" at Body Station 920. The crush measured by the crash investigators team was 7" at Body Station 380, 14" at Body Station 460, 10" at Body Station 540, and 13" at Body Station 820. Both teams had good agreement in the crush measurements at Body Station 380 and Body Station 540. At the other body stations measurements were made by only one team.

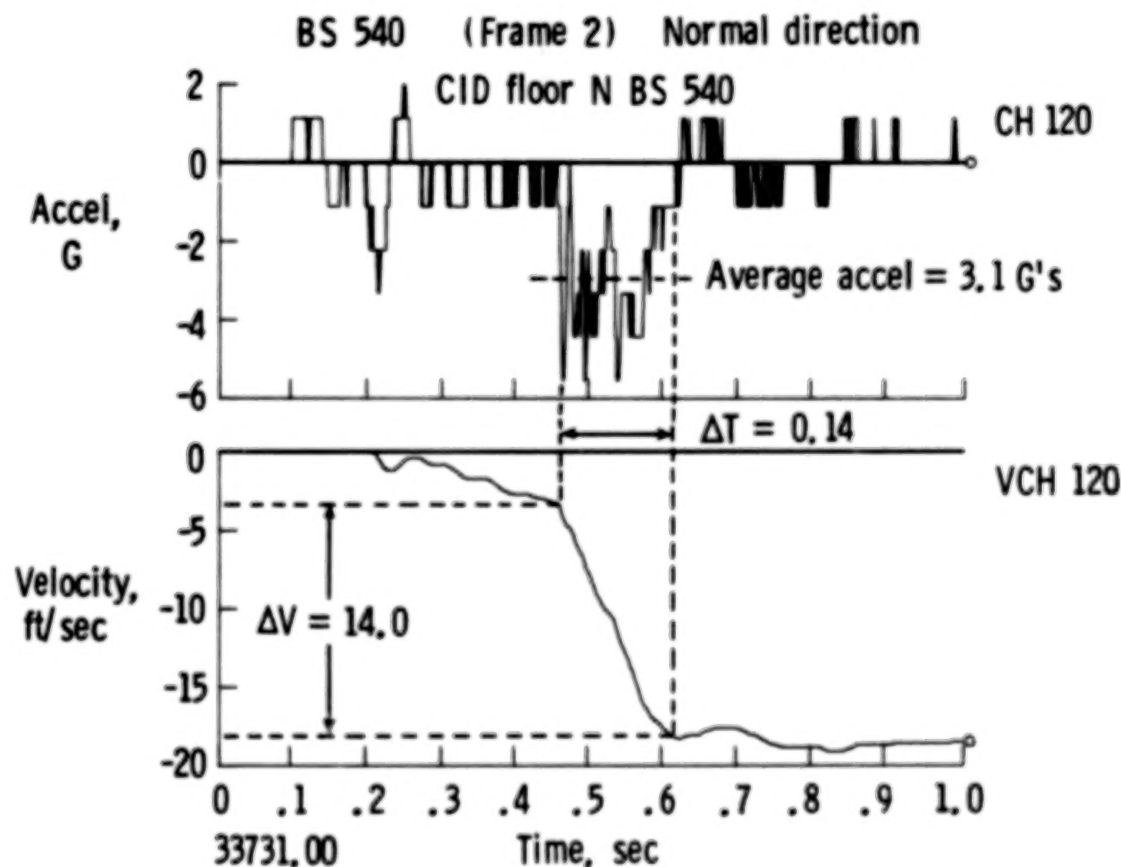
Figure 14

The top plot in figure 14 is of the normal acceleration of the floor at body station 540. The bottom plot shows the velocity curve obtained by integrating the top acceleration plot. The dominant acceleration pulse from 0.48 to 0.62 seconds in time occurs when the fuselage impacts the ground. The acceleration from 0 to 0.48 seconds is from the left wing impact. Notice that the total vertical velocity change is approximately 18 ft/s, but that the velocity change is composed of almost 4 ft/s taken out by the wing and about 14 ft/s taken out by the fuselage. The average acceleration for the fuselage impact can be computed from delta V of 14 ft/s divided by delta T of 0.14 seconds which when expressed in G-units is 3.1 G's. If the acceleration from 0.48 to 0.62 seconds were a triangular pulse, then the peak would be twice the average or 6.2 G's. For this example, twice the average acceleration and the peak acceleration directly from the plot are nearly the same. The average acceleration and twice the average acceleration are useful indicators in data interpretation of crash impact severity.

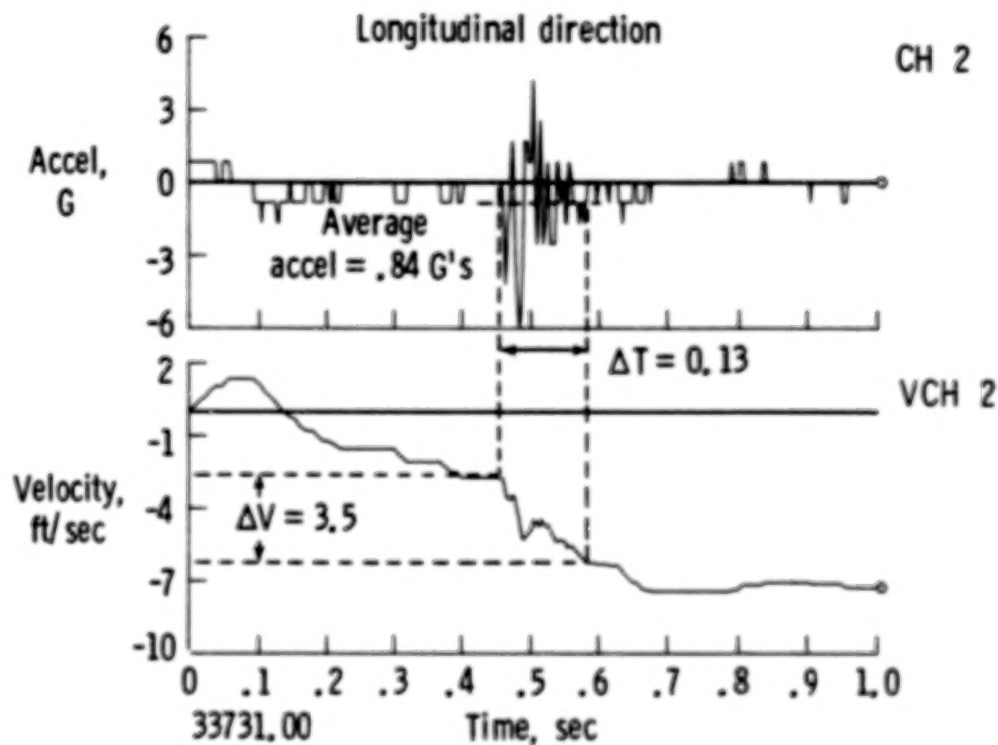
Figure 15

Using the same technique as in figure 14, the longitudinal acceleration of the pilot floor is analyzed for the 0.13 second pulse shown in figure 15. Note that the average acceleration is only 0.84 G in this case. Twice the average acceleration, which would correspond to a 0.13 second triangular pulse, would only have a peak of 1.68 G's. The peak G taken from the top trace is about 6 G's, but it is of very short duration. The average acceleration or peak triangularized acceleration has more meaning in this case and can be compared with other locations in the aircraft with better results.

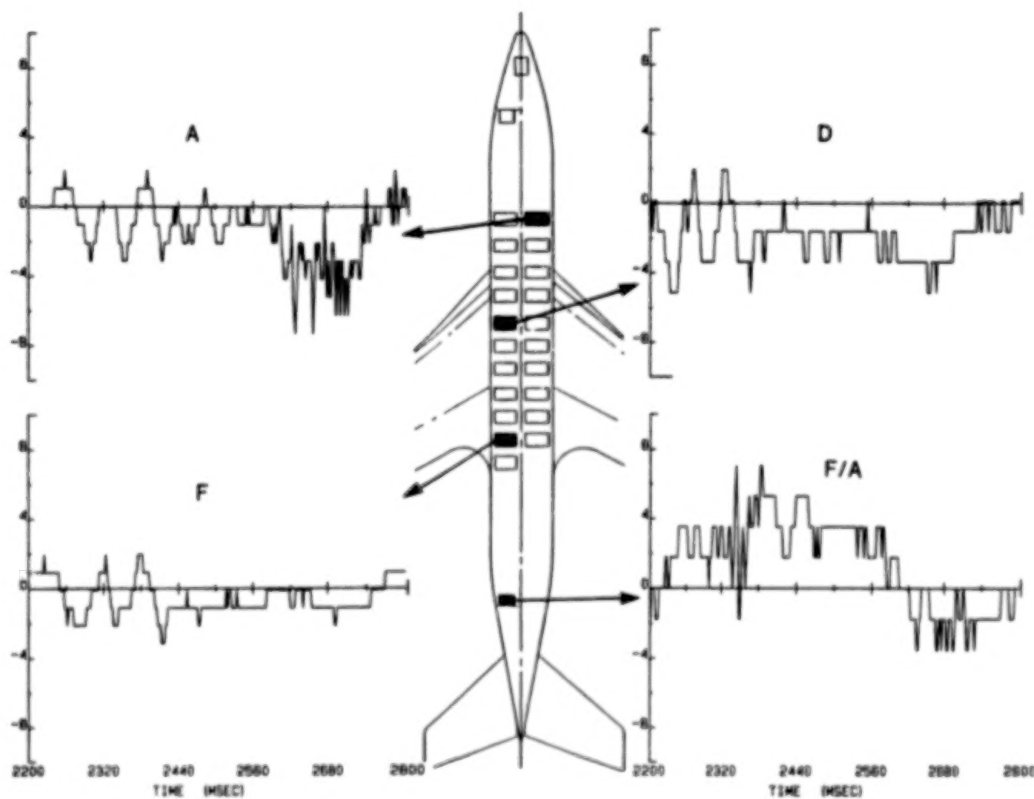
Figure 9.

Figure 9 shows vertical acceleration during ground impact. This includes the engine, and then the fuselage, striking the ground. Accelerations are shown for four different points in the aircraft, at the aft flight attendant seat and at three other points along the length of the cabin. There are accelerations similar to those shown in reference 2: 2-4 G accelerations at most locations and somewhat higher at the flight attendant seat. The data is consistent with the physical observations made after the test. Figures 10 and 11 show the longitudinal and lateral components of accelerations at the same locations.

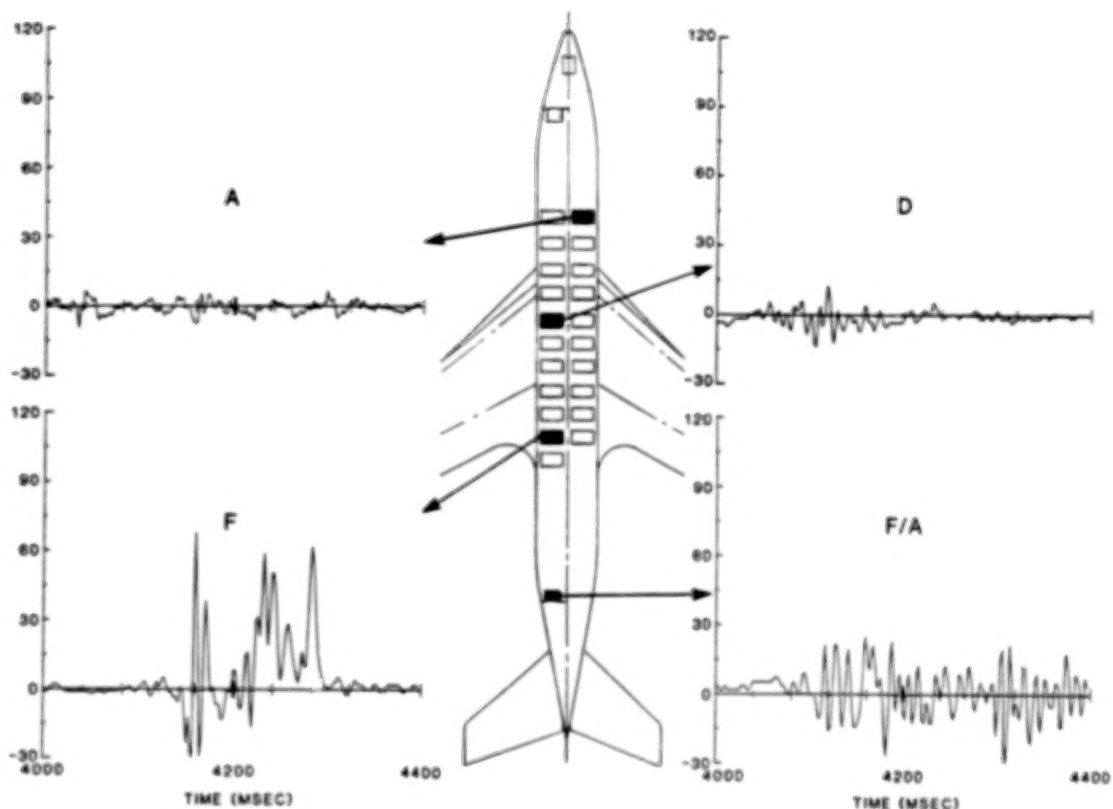
Figure 12.

When the aircraft hit the obstacles there were some 15- to 20-G vertical acceleration peaks. (See fig. 12.) They were very sharp peaks, with little energy. That is typical of data for all three coordinate axes. The channel for seat F shows a higher acceleration, but it is not really consistent with the other channels. (Apparently an instrumentation problem existed.) This channel behaved well during ground impact, but not after the aircraft hit the obstacle. Serious doubt exists that there were accelerations of such magnitude. Figures 13 and 14 show the longitudinal and lateral acceleration components at the same locations.

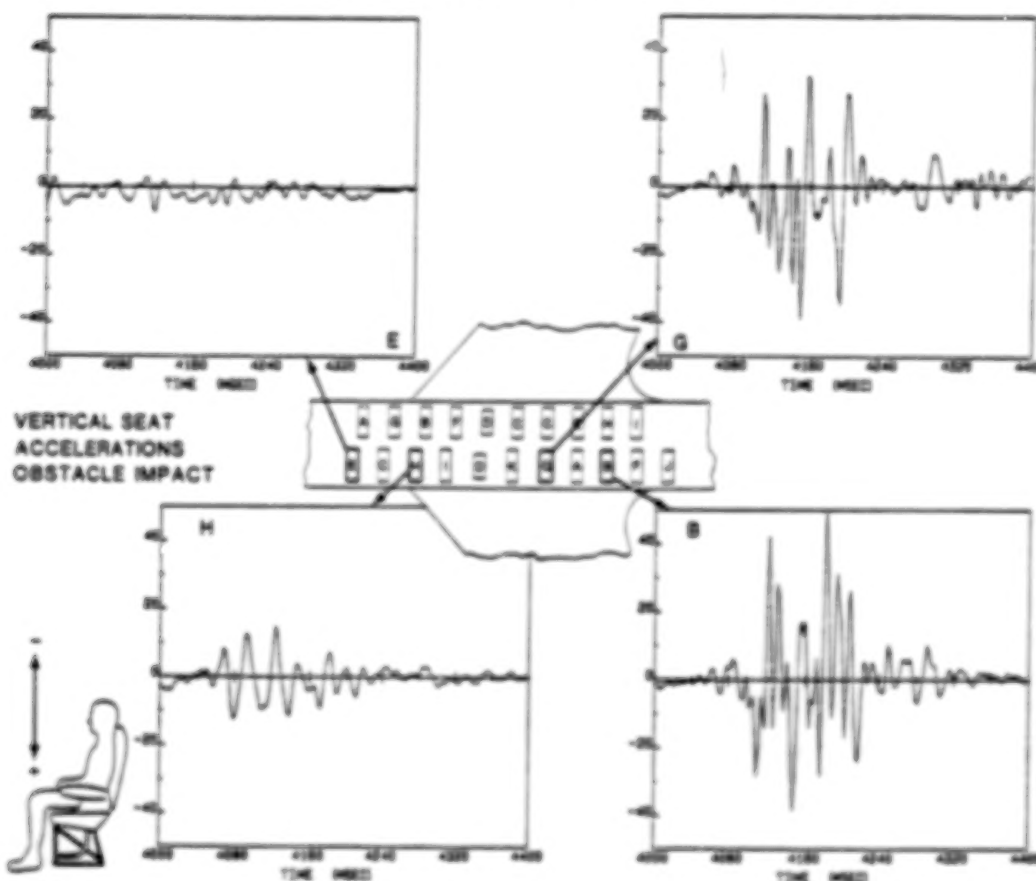
Figure 18.

The vertical seat accelerations for four seats along the length of the aircraft are shown in figure 18, which shows that the accelerations on those seat pans during obstacle impact are a function of position along the aircraft. There are some higher values than were seen on ground impact. There are very brief and occasional accelerations of over 20 G; sometimes there is a sharp spike up to 40 G. However, they are extremely steep and narrow and represent very little energy. It therefore does not appear unusual for unmodified seats to have survived this impact.
